## **EXECUTION INTERNSHIP REPORT 1A**

*Quality control and metrology on a diesel cylinder  
block machining line*

RENAULT GROUP - CLEON PLANT

Cleon (Seine-Maritime, France) - 22 June to 17 July 2026

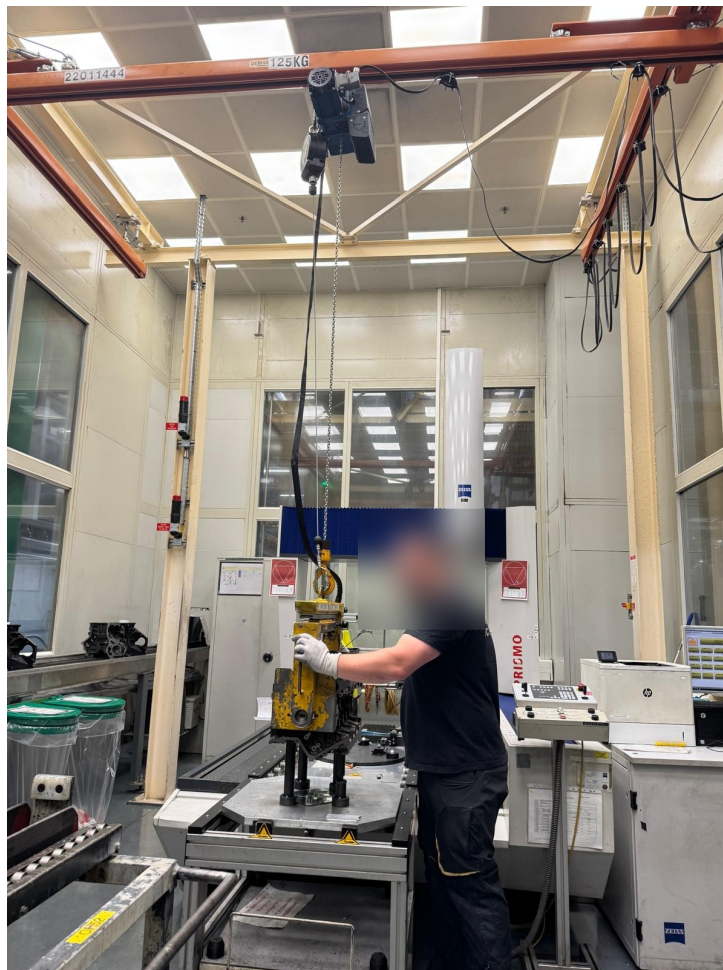
**Image 2.** Positioning a cylinder block on the fixture of the Zeiss Prismo 3D coordinate measuring machine, using a chain hoist (125 kg capacity).

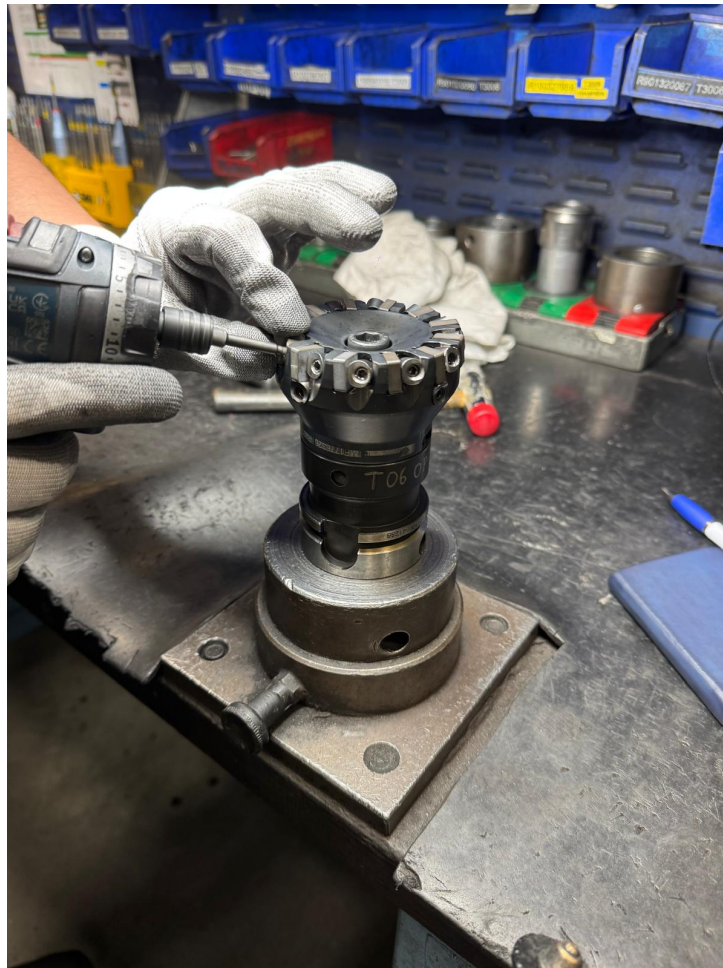
**Image 3.** Changing a carbide insert on a finishing milling cutter (HSK cone), using a torque screwdriver.

Changing a carbide insert follows a precise procedure: unscrewing, a visual check of wear, then either scrapping it or turning it onto an unused face, cleaning, refitting and tightening to the specified torque. Once adjusted, the milling cutters and drill bits are gathered on a trolley before being brought back to their station on the line.

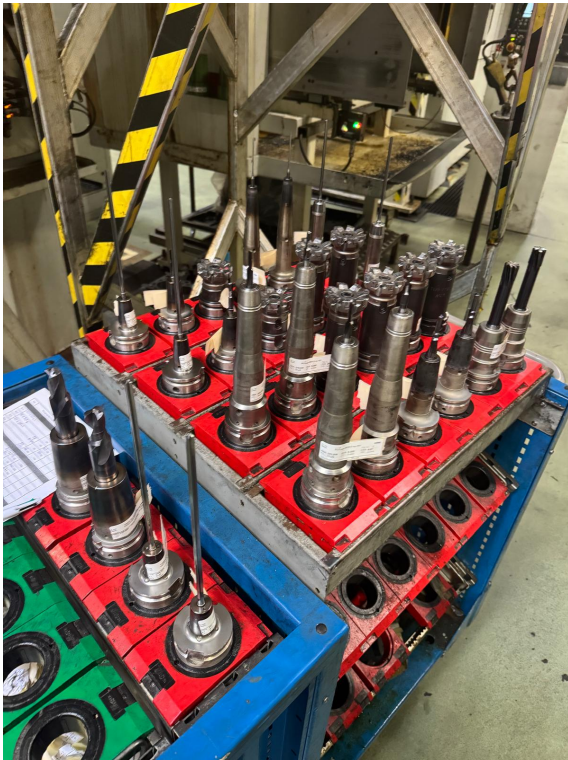
**Image 4.** Trolley loaded with adjusted milling cutters and drill bits, ready to be refitted at the workshop's stations.

On more complex tools, the height of each insert then has to be checked on a dedicated optical presetting machine (Zoller bench), which automatically measures the tool's diameter and position by camera. Only inserts sitting too low need to be raised, using adjustment screws: I would loosen slightly, measure, adjust, then re-tighten to torque, working in small increments so as not to put too much strain on the tool.

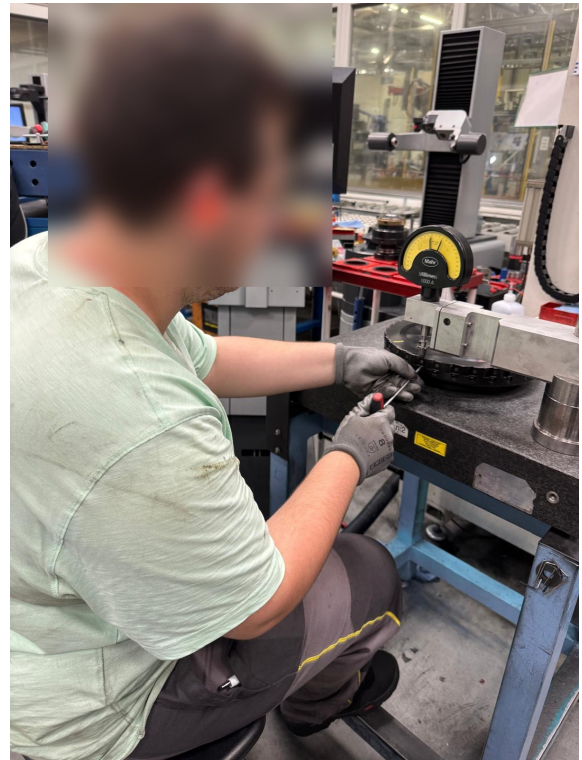
**Image 5.** Adjusting a milling cutter on the metrology surface plate, using a Mahr Millmess dial gauge.

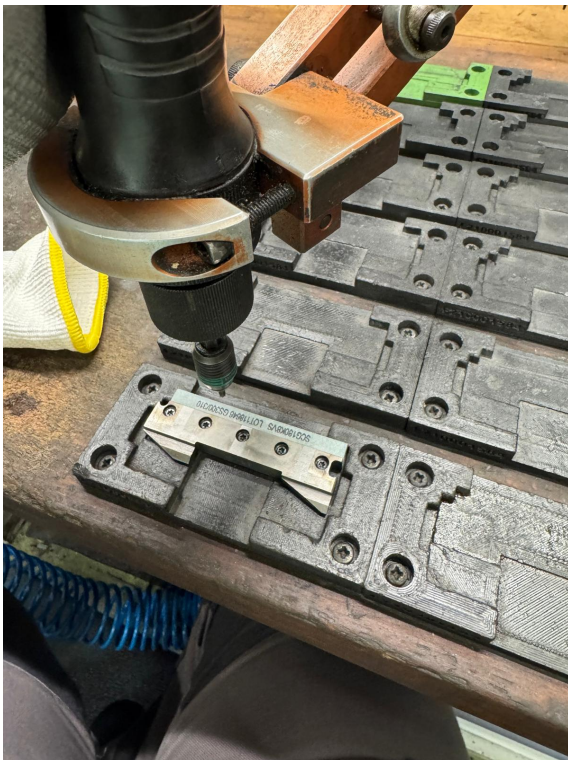
**Image 6.** Changing a honing stone, mounted in its holder.

Honing heads follow a fairly similar logic: their position depends on several pneumatic nozzles, whose pressure and flow rate must be perfectly matched to guarantee an even result (an imbalance between them is enough to throw off the adjustment, as I found out later in the internship, see section 3.7). Over several days, I also took part in changing several honing stones, which are screwed into their metal holder.

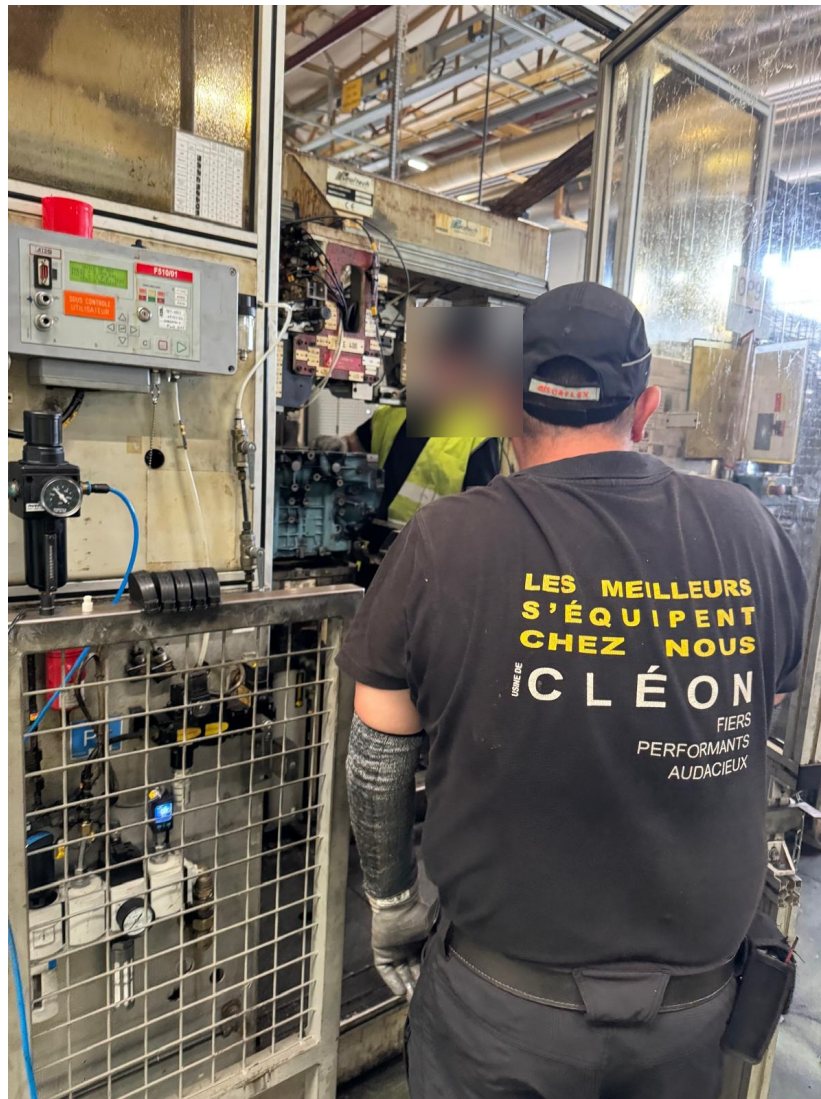
**Image 8.** The leak-tightness test bench (ATEQ F510/01 unit, on the left) at the time of the incident.

The most representative episode of the work I carried out involves a major breakdown of the cylinder block leak-tightness test bench. A “high” or “low” cylinder block is a block variant defined by the different positioning of certain components; for about a month, the workshop had only been making high blocks, so low blocks had not gone through the leak-tightness bench in all that time. When production of low blocks resumed, the ambient heat revealed that the seals on that unused part of the bench had degraded: the problem then spread, to the point that no block, high or low, could pass the test any more. This quickly brought the whole line to a halt, since no part could move from the rinsing station to the next visual inspection step without prior validation.

*“No block (high/low) is passing the leak-tightness test because the test machine hadn’t run for a month, and the heat destroyed the seals. [...] The workshop is stuck, no part is moving from rinsing to visual inspection any more.”*

Faced with this blockage, the diagnostic approach was to proceed by elimination: an attempted repair with oil, without success, then grease was applied to each of the bench’s “air pipettes,” one by one, to isolate the source of the leak. After several hours of investigation, and despite the problem initially persisting on the high side of the block while the low side worked normally, the cause was finally identified: a worn seal combined with a localised lack of grease. Replacing it allowed production to restart.

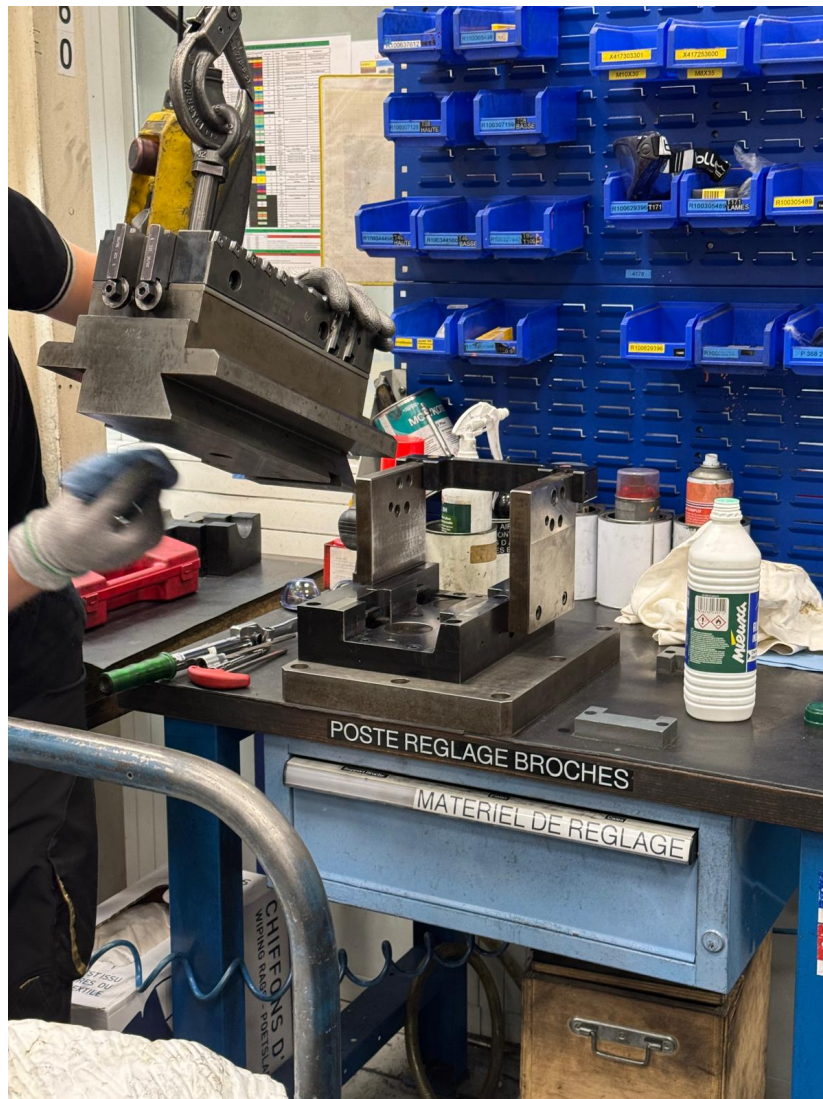
**Image 11.** The workshop's broach adjustment station: adjusting a precision tool suspended from a hoist, on its reference fixture.

One day was spent, in the workshop's tooling section, adjusting a fixture on the bearing caps, requiring "micron-level" precision: the reference part is positioned on a master gauge, and each adjustment screw has to be fine-tuned very precisely (marks drawn in white marker keep track of their original position), with a deviation of 24 microns measured, for example, during my time there. Adjusting a single screw from scratch takes around four hours of work, with the fixture having to be unlocked on six sides at each iteration, which makes the operation particularly time-consuming.

Once the adjustment is finished, the "broach" (nicknamed "brocheton" in the workshop) is put back in place; since this part is very heavy, moving it requires a hoist. It was also at this station that I saw [REDACTED], the team leader, work directly on a broach: using a high-pressure air blower, he cleared out metal chips and coolant residue before it was re-measured, a simple but essential maintenance step to avoid throwing off a micron-level adjustment. This is not normally his role, particularly when it involves working inside the machines themselves: seeing him do it mostly reflects a shortage of staff and resources for this kind of station.

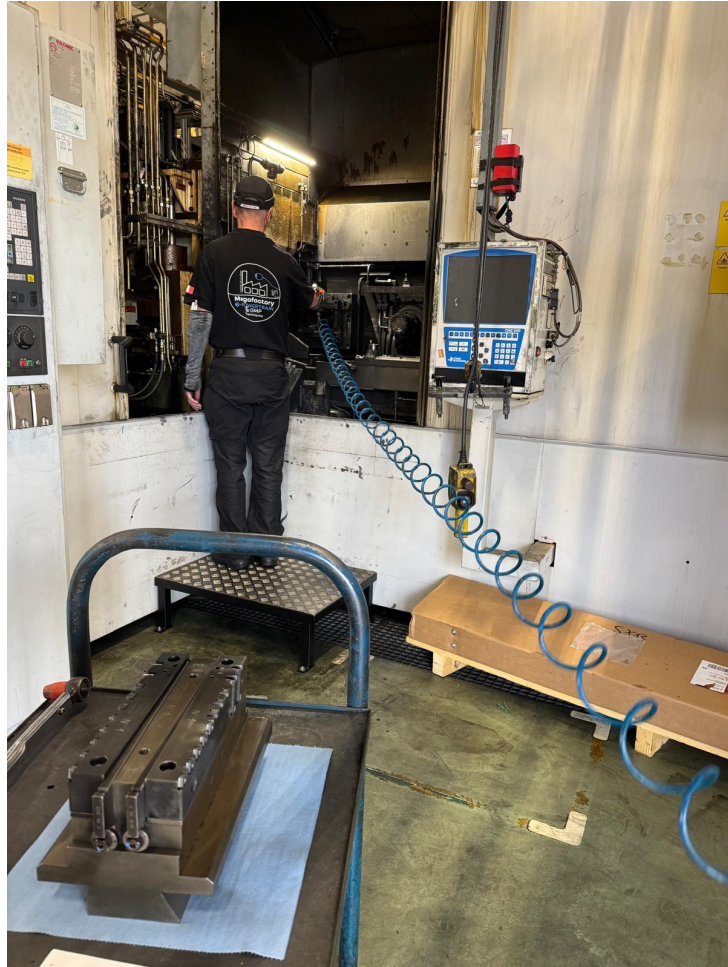
Image 12. [REDACTED], the team leader, adjusting a broach with a high-pressure air blower to remove metal chips and coolant.

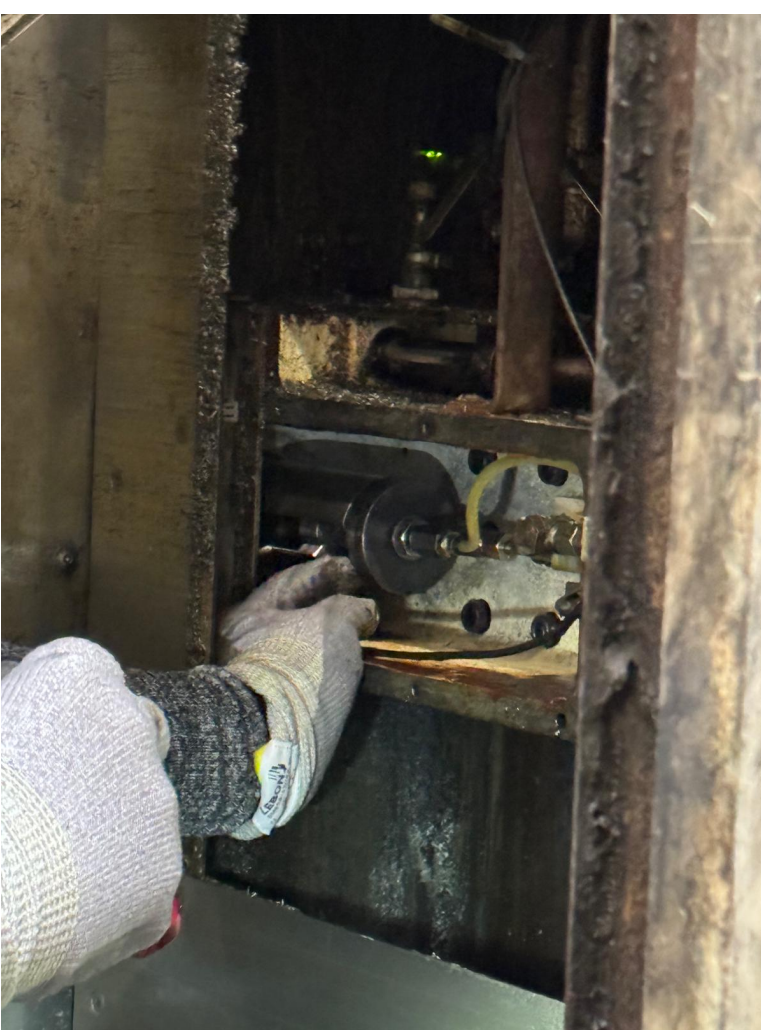
**Image 13.** Working on the sensor mentioned above, inside the machine.

A second intervention, the same day, dealt with a sensor that had shifted: it had moved by three tenths of a millimetre because of the ambient heat, throwing off the measurement. The procedure involved stopping the machine cycle, opening the door and then the access hatch, unlocking the fixture, and readjusting it. I took part in this by holding the screws and the access hatch, while a technician, watching a control screen some distance from the work area, indicated whether the sensor was moving the right way. The first adjustment of the brocheton turned out to be insufficient (two parts measured afterward still showed a deviation), so a further correction was needed. I then helped clean and dry the parts (washed in the machine, then dried with a compressed-air gun) ahead of their re-measurement.

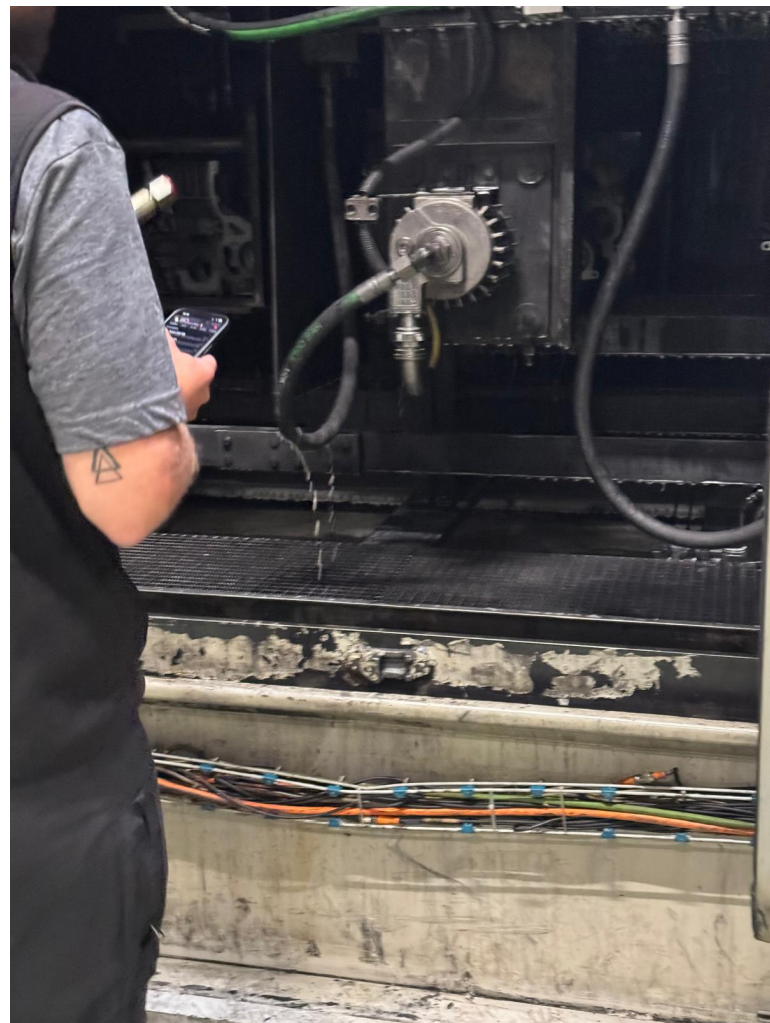
**Image 16.** The leak on the washing machine hose mentioned above, located at a fitting.

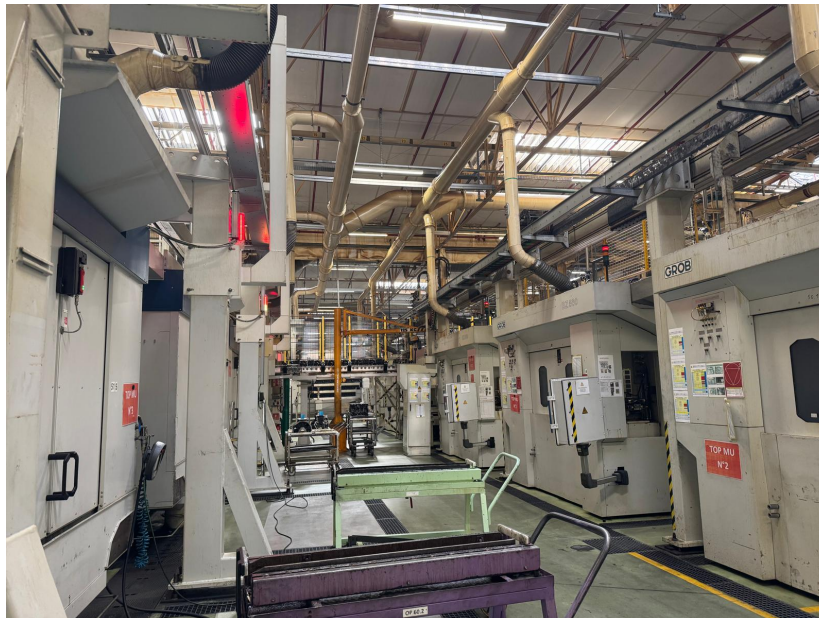
**Image 21.** An aisle of the cylinder block machining workshop, fitted with GROB machines (the workshop has several aisles like this one).

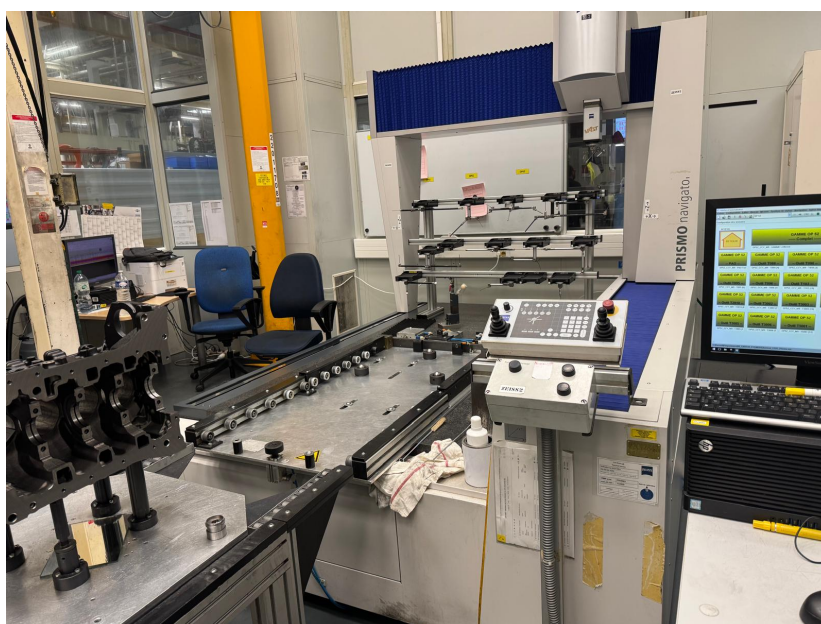
**Image 25.** 3D coordinate metrology room fitted with the Zeiss Prismo Navigator machine.

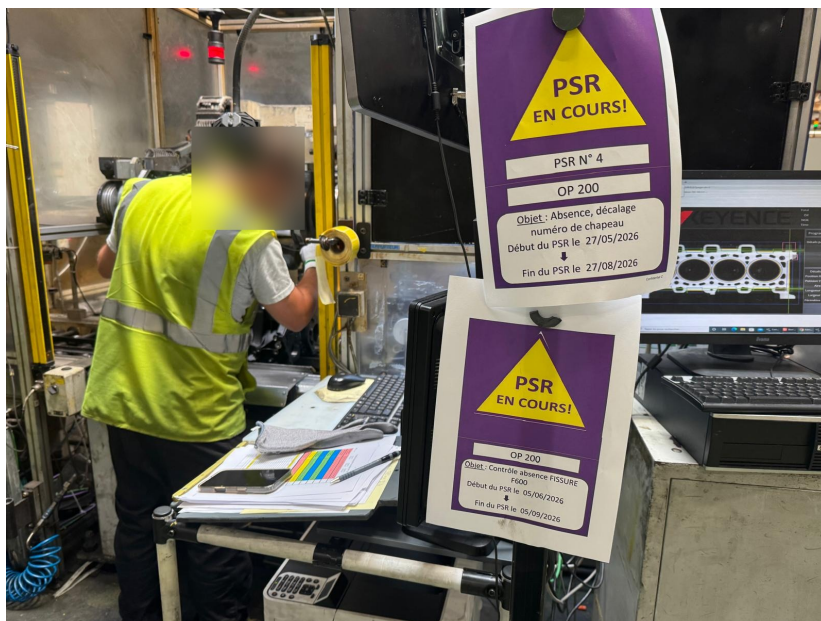
**Image 27.** Laser scanner inspection station, with two Enhanced Monitoring Plan (PSR) sheets displayed. The first concerns “missing or shifted bearing cap number”: a block’s five bearing caps are numbered 1 to 5 and must be fitted in that order, but on some blocks the order is occasionally reversed, or the number is not visible at all; while this has no effect on engine operation, it still has to be reported to Nissan, who requires it contractually. This defect echoes the bearing cap adjustment described in section 3.5.

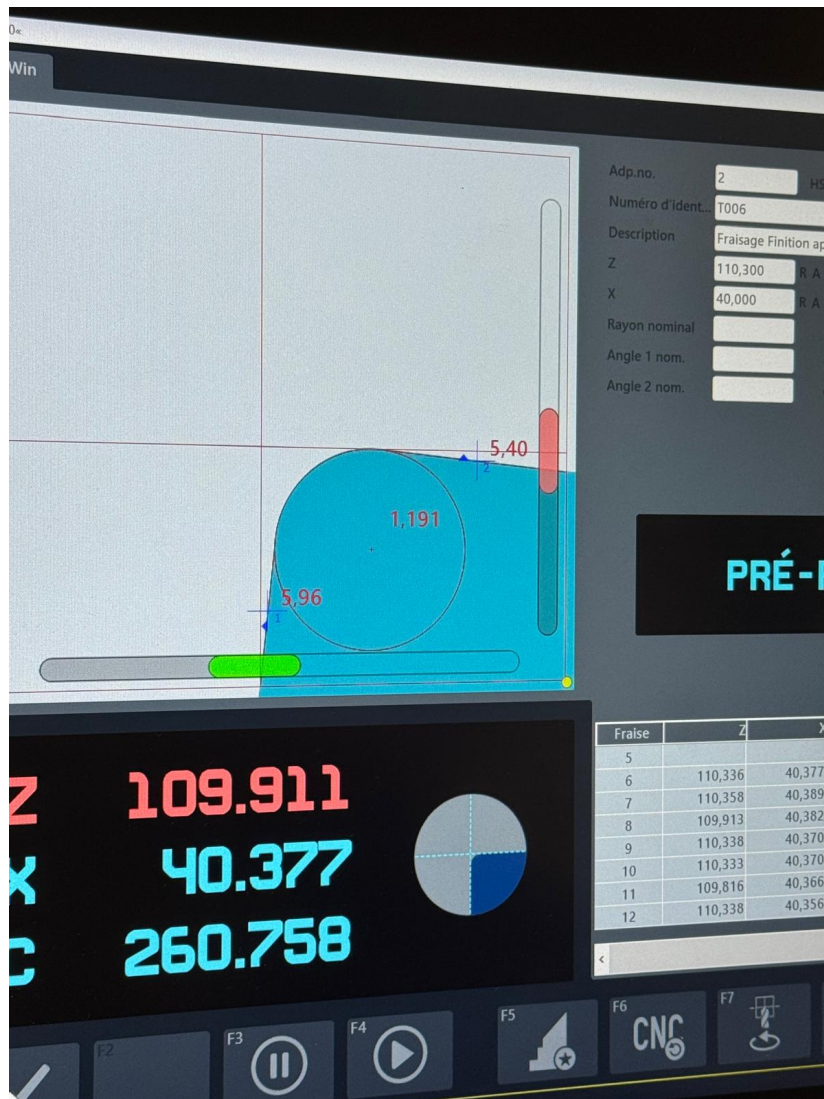
**Image 28.** Screen of the tool presetting bench (Zoller, pilot 4.0 software): measuring the diameter and position of a finishing milling cutter before refitting.

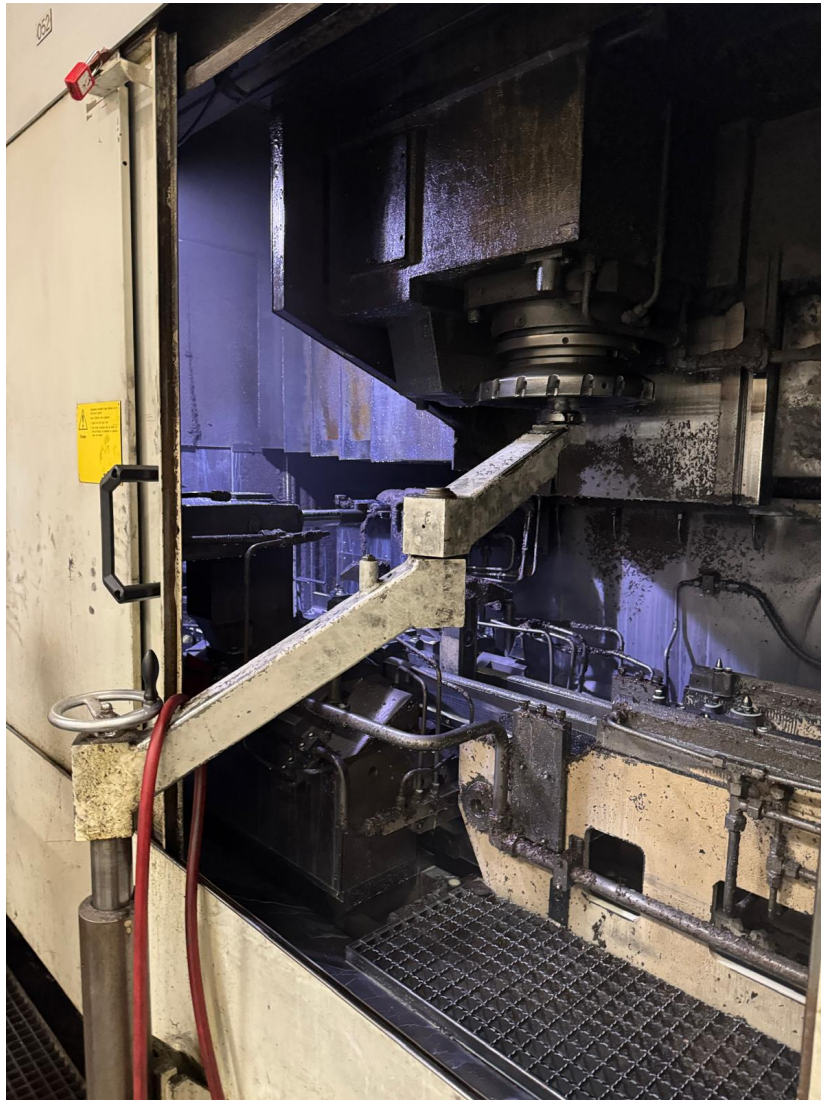
**Image 30.** Inside one of the workshop's machine tools (cylinders, hydraulic and pneumatic hoses, cable chains), with the lifting arm used to fit and remove the milling cutter: this kind of access requires a lockout padlock to be fitted beforehand.

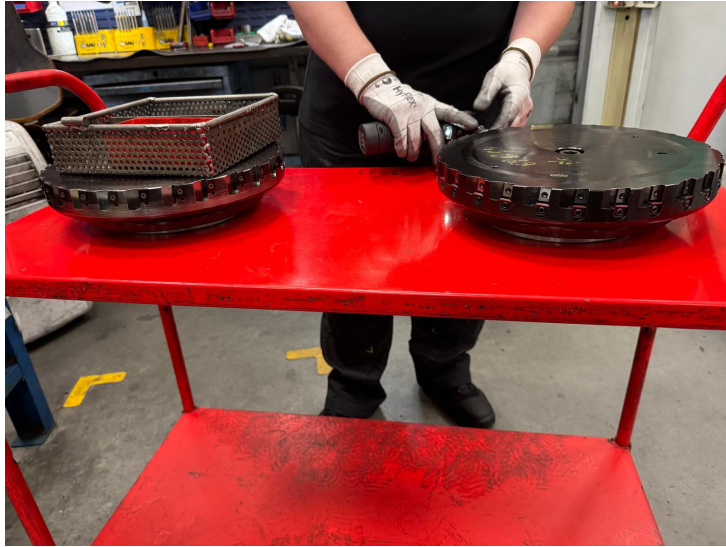
**Image 33.** Insert-tipped circular milling cutters from the machining line, placed on a workshop trolley before inspection and refitting.

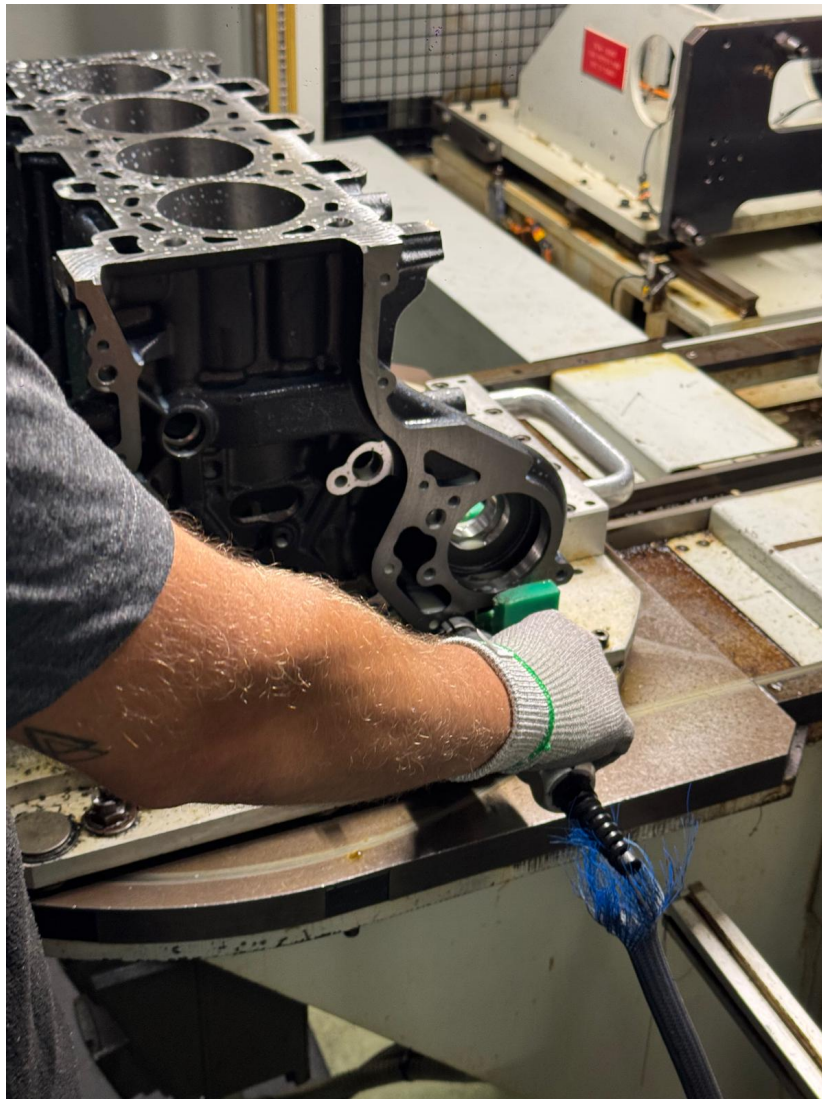
**Image 34.** Checking the inner diameter of a blind hole in the block with a pneumatic gauging tool, wearing a cut-resistant glove.

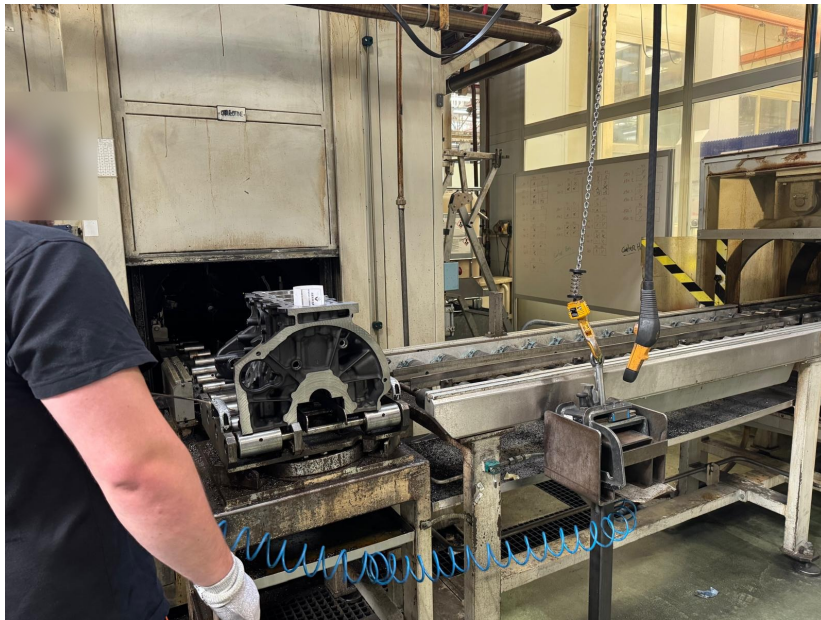
**Image 35.** Cylinder block coming out of the washing machine: the compressed-air gun's hose (in the foreground) is used to blow off the water before sliding the part onto the conveyor leading directly to the 3D inspection room.
